Manhole Inspection Summary

Manhole # S69S__017MH

Record Plat: **69S** Node: **017** Status: **Found**

Location Address: **6700 Roberts Ave.**

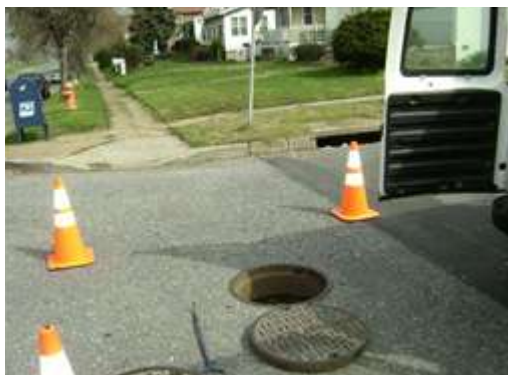
Location View

Road on a down hill slope. Sheeting possible.

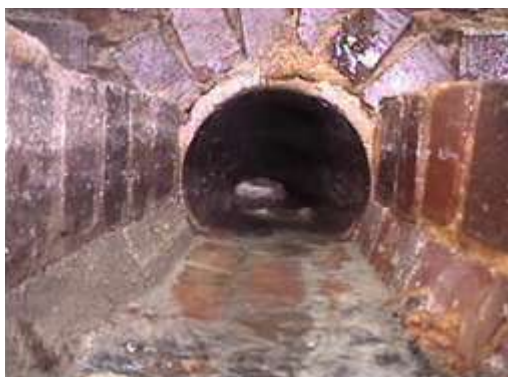
Defect 6

12'oclock pipe cracked

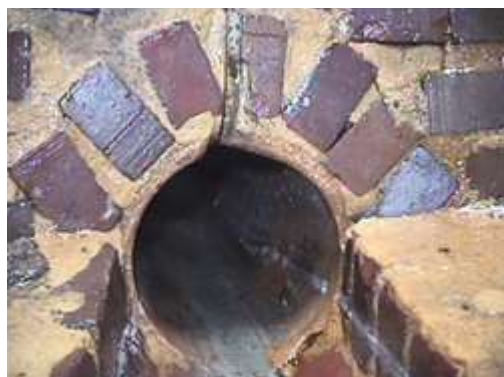
Defect 5

3'oclock to the 6 pipe broken. Multiple pipe seal cracks 12 to the 2.

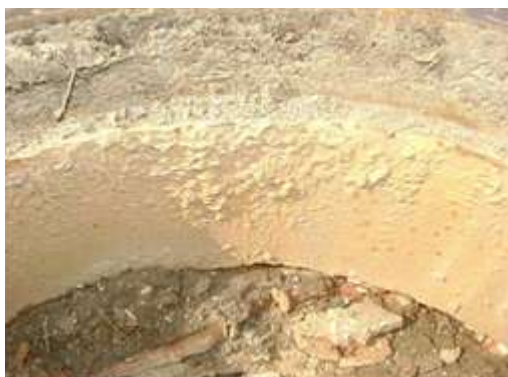
Defect 3

Condition: ☐ Sound ☐ Cracked ☐ Root Intrusion ☒ **Loose Brick** ☒ **Deteriorated**

Deterioration-chimney frame

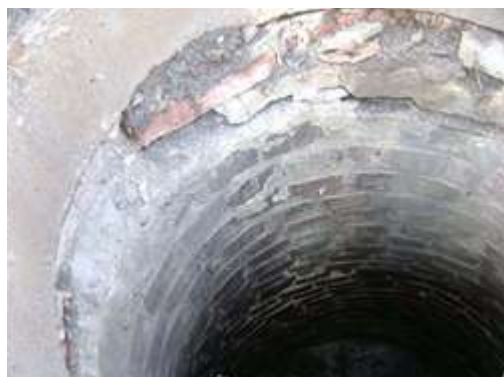
Defect 1

Offset: **3** (in.)

Condition: ☐ Sound ☒ **Cracked** ☐ Leaks

Offset Frame

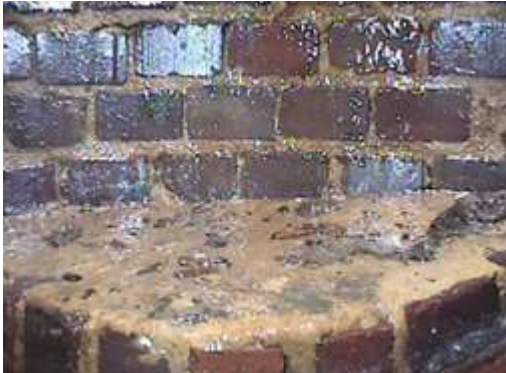
Defect 7

Comments **STREAMS OF WATER INFILTRATING IN FROM JOINT BETWEEN BENCH AND BARREL.**

Infiltration: ☐ None ☒ **Joint** ☐ Cracks ☒ **Mortar** ☐ Roots ☐ Wall

Infiltration Running Down Barrel

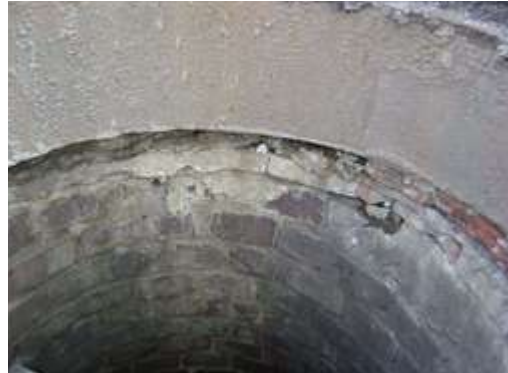
Defect 2

Loose Bricks-chimney frame

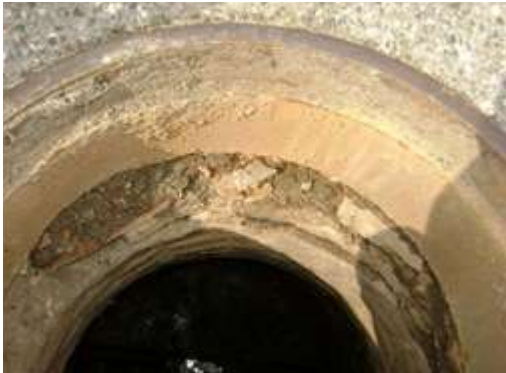
Defect 4

Infiltration: ☐ None ☒ **Joint** ☐ Cracks ☐ Mortar ☐ Roots ☐ Wall

Infiltration from chimney frame
deterioration of joint and mortar.

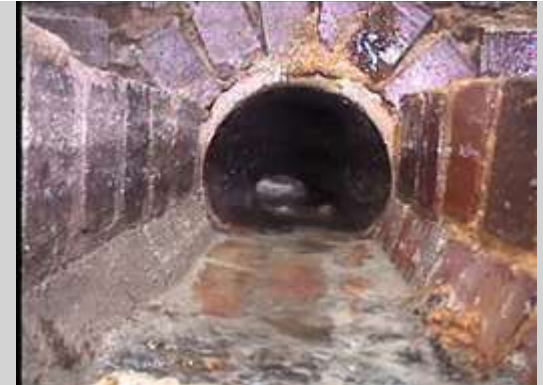
12 O'Clock Outflow

Pipe Height: **8.4** (in.) Rod and Bar (Angled)
Pipe Material: **Clay** ☐ Pipe Lined
Invert Depth: **8.33** (ft.) Flow Characteristics: **Slow**
Deposits: ☒ None ☐ Mud ☐ Sludge ☐ **Debris** ☐ Grease
Silt Depth: (in.) Deposits Extent:
Infiltration: **None** Pipe Seal Cond: **Cracked**

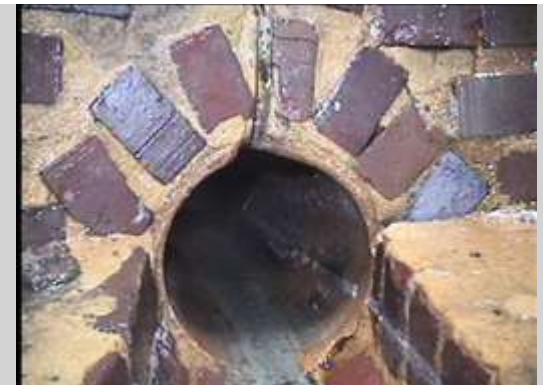
3 O'Clock Inflow

Pipe Height: **8.4** (in.) Rod and Bar (Angled)
Pipe Material: **Clay** ☐ Pipe Lined
Invert Depth: **7.92** (ft.) Flow Characteristics: **Slow**
Deposits: ☒ None ☐ Mud ☐ Sludge ☐ **Debris** ☐ Grease
Silt Depth: (in.) Deposits Extent:
Infiltration: **None** Pipe Seal Cond: **Broken**

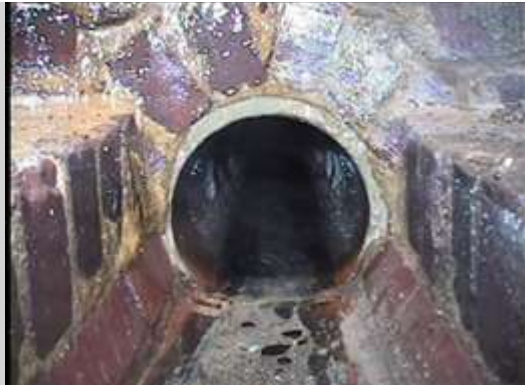
6 O'Clock Inflow

Deposits: ☐ None ☐ Mud ☐ Sludge ☒ **Debris** ☐ Grease

Silt Depth: **1** (in.) Deposits Extent: **Heavy**
